# ANALYSIS OF SHIP BEHAVIOR IN TSUNAMI USING AIS DATA

Shigeaki Shiotani<sup>1</sup>, Hidenari Makino<sup>2</sup> and Daisuke Terada<sup>3</sup>

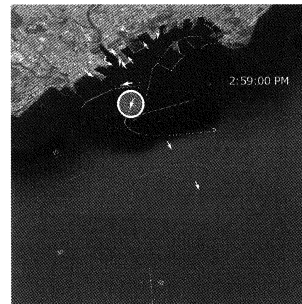
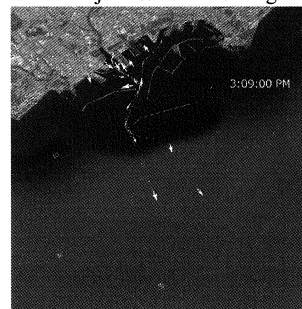
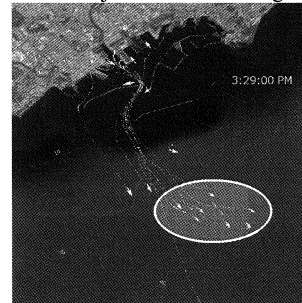
**Fig.3** Evacuation Status of Vessels after the Major Tsunami Warning Announcement

(a) 10 min after the Major Tsunami Warning Announcement

(b) 20 min after the Major Tsunami Announcement

(c) 30 min after the Major Tsunami Warning Announcement

(d) 40 min after the Major Tsunami Warning Announcement

**Fig. 3** shows an example that depicts the status of emergency evacuation of each vessel on the basis of the AIS data obtained from the Onahama Port areas. Each white arrow in the figure indicates a vessel. The broken white lines show the paths of the vessels during a 30-min period. The solid white lines indicate the contour lines. **Fig. 3(a)** shows the conditions around the port at 2:59 pm, 10 min after the major tsunami warning, and indicates that each vessel had started preparing for evacuation. The tanker white circled in the figure entered the port just before the announcement of the major tsunami warning. Upon the announcement, it hastily turned around and prepared for evacuation from the port. The figure also shows several vessels that were preparing for evacuation. **Fig. 3(b)** depicts the

condition at 3:09 pm, 20 min after the announcement. We confirmed that most vessels in the port were prepared for evacuation, while several ships had already moved out of the port. The tugboats (indicated by the small arrow) in the port were prepared and had already started evacuating 20 min after the major tsunami warning announcement. **Fig. 3(c)** shows the condition of the port at 3:19 pm, 30 min after the major tsunami warning announcement. It indicates that the cargo ships and tankers that can independently leave the port initiated emergency evacuation. The vessel white circled in the figure evacuated the port via a different route than usual, suggesting the state of emergency of this event. **Fig. 3(d)** depicts the condition of the vessels around the port at 3:29 pm, 40 min after the major tsunami warning announcement. At this point, most vessels that left the port had already evacuated to approximately 4.5 miles (approximately 7.2 km) off the coast, which is indicated by the white circle, an area with water depth of 40–50 m. As explained in Chapter 2, this was an extreme state of emergency and the first wave of tsunami (height of 1.0 m) arrived 3 min after the major tsunami warning announcement. Even in this dire situation, the vessels took a prompt and appropriate action after the announcement, leaving the port within 30 min and completing the evacuation in about 40 min.

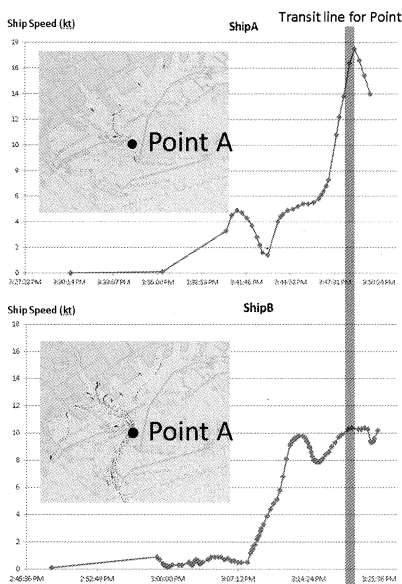
Fig.5 Velocity Comparison between Vessel Aground and Vessels Evacuated
