INVESTIGATION OF SHORELINE CHANGE CAUSED BY THE GREAT EAST JAPAN TSUNAMI 2011 AROUND SAMEGAWA RIVER MOUTH

Mohammad Bagus Adityawan¹, Hitoshi Tanaka² and Hisao Nagabayashi³

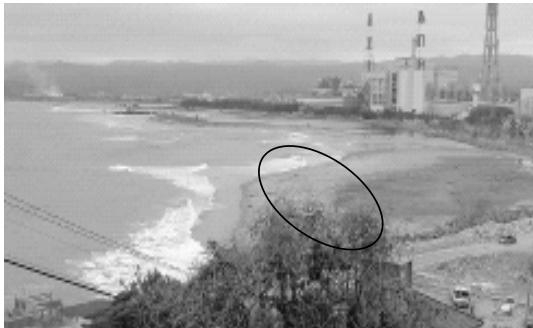
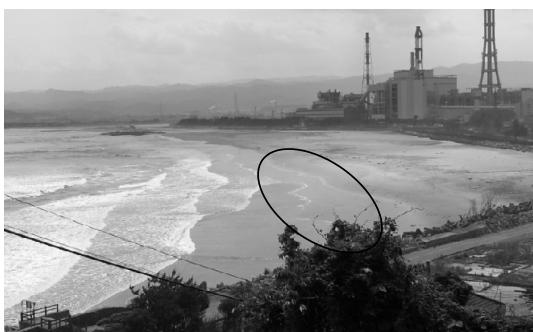
Fig.3 Shoreline retreat.

2011-04-18

2012-06-07

Location: Fig.2-Box A

Satellite images for the study area were collected from Google Earth for 27 April 2005 (DigiGlobe, resolution 0.6 m), 12 March 2011 (DigiGlobe, resolution 0.6 m), and 28 February 2012 (GeoEye, resolution 0.5 m), representing the condition before the tsunami, immediately after the tsunami, and present. In addition, an aerial photo was acquired showing the condition on 1 November 2011. The satellite images and the aerial photo are shown in **Fig. 2**. Field observation was conducted and photos were taken. **Fig. 3** shows the condition of the shoreline shortly after the tsunami and the most recent condition. It can be seen the retreating and the breaching of the shore line.
