REBUILDING COMPOSITE BREAKWATERS FOLLOWING THE 2011 TOHOKU TSUNAMI: LESSONS LEARNT AND DOES IT MAKE SENSE TO REINFORCE?

Key Words : breakwaters, Tohoku, tsunami, armour units, laboratory experiments

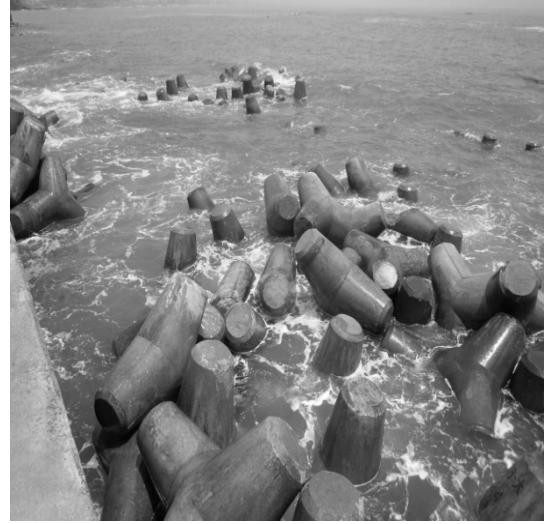
Fig.1 Damaged Sea-Block armour at Ooya Port

Miyagi, Fukushima, Ibaraki and Chiba prefectures (Mori et al. 2012, Mikami et al. 2012). During these inspections detailed surveys of the failure of armour layer at various breakwater locations along the affected coastline were made. Two of these were composite breakwaters, those of Hikado and Ooya ports (see Fig. 1), located close to Kesennuma City. These two breakwaters are situated fairly close to each other and are facing the open sea, meaning that the tsunami waves would have attacked them directly. Three different measurements of wave heights were taken in this area, 15.7m (by the authors themselves) and 16.55 and 15m (by other members of the Tohoku Earthquake Tsunami Joint Survey Group). In the present analysis the authors have thus adopted their own value of 15.7m for the tsunami height at the breakwater, as it sits roughly half way between the other two values measured by the other teams.

Three different types of armour units were present at the breakwaters surveyed. Ooya port is made of Sea-Lock, and Hikado port has both X-block and Hollow Pyramid units along the breakwater (X-blocks in the body of the breakwater and heavier Hollow Pyramids at the head). The X-blocks and Sea-Blocks armour completely failed, and the armour units were scattered over a wide area in front of the breakwater, with only the top of some of the units still showing above the water surface. The exact failure mechanism is unclear, and whether the units were displaced by the incoming or the outgoing wave is not so easily established. In any case, the breakwater was overtapped with the whole of the area being completely underwater at one point during the tsunami attack (which would have also generated large underwater currents in the area).

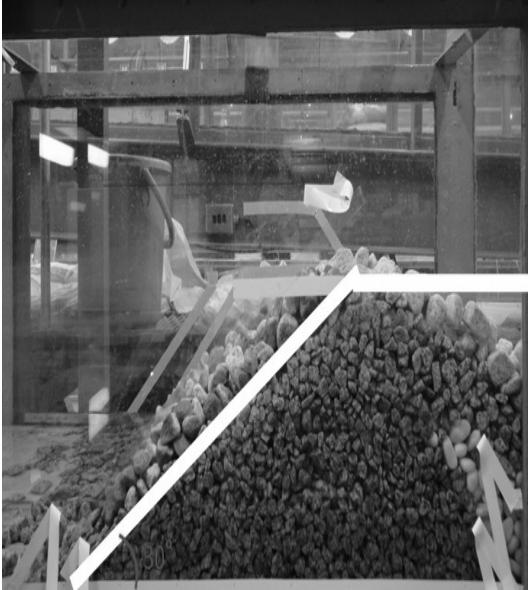
Fig.2 Experimental layout of the breakwater

Laboratory experiments were carried out using solitary waves generated by a wave paddle in a wave flume at Waseda University in Japan as shown in Figs. 2 and 3 (dimension 14m long, 0.6m high, 0.41m wide). On one side of the tank a caisson breakwater was placed, which was protected by an armour layer made up of stones of different sizes (a total of 3 different stone sizes were used, with median weights W of 27.5, 32.5 and 37.5g) to test the sensitivity of armour weight on breakwater damage. Two different breakwater configurations were also tested (with a seaward angle θ of 30 and 45°). Each of the breakwater configurations was also tested for three different water depths, $h = 17.5$, 20 and 22.5cm. The number of armour units extracted after one solitary wave was counted with the aid of a high-speed photographic camera, and each of the experimental conditions was repeated 15 times to ensure accurate results.
